D3.9_Overall Refurbishment Plan

CS14 Wilmcote House

Portsmouth, UK

EuroPHit

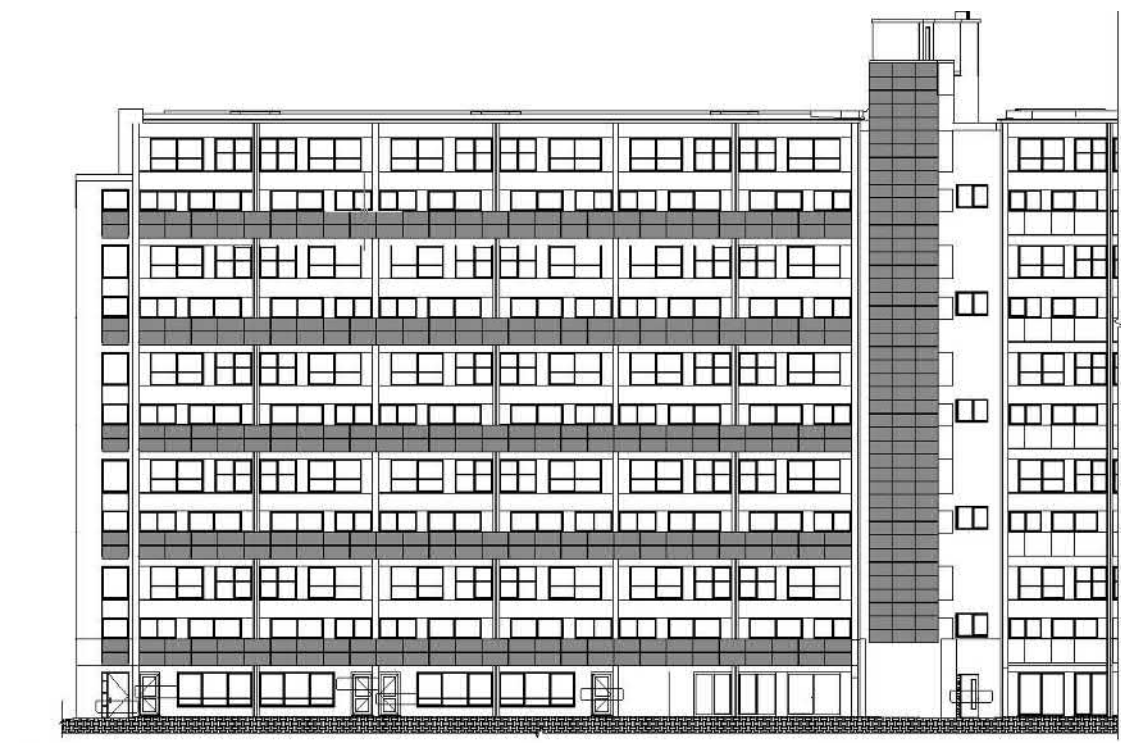
Figure 14 Block A garden façade view

Block A and stair core B: The ventilated façade would be located in the garden façade, covering the opaque walls. The scheme of the PV integration is shown below:

This is an alternative solution for external walls that is composed by an insulation material in the inner part, an air gap and PV modules in the outer layer. This system could be implemented to reduce thermal exchanges and to avoid thermal bridges, producing at the same time clean electricity. Thanks to the ventilated air chamber and to the application of insulating material, this system increases the acoustic absorption and reduces the amount of heat that buildings absorb in hot weather conditions. In the air gap, the density difference between a hot and cold air creates a natural flow removing the air through a chimney effect that helps to eliminate heat and moisture increasing inner comfort.
