EuroPHit_CS01_Elderly Home_Ireland

1.1.1 Window cill detail for the existing concrete wall - THERM

1.1.1 Window cill detail for the existing concrete wall - Site Photo

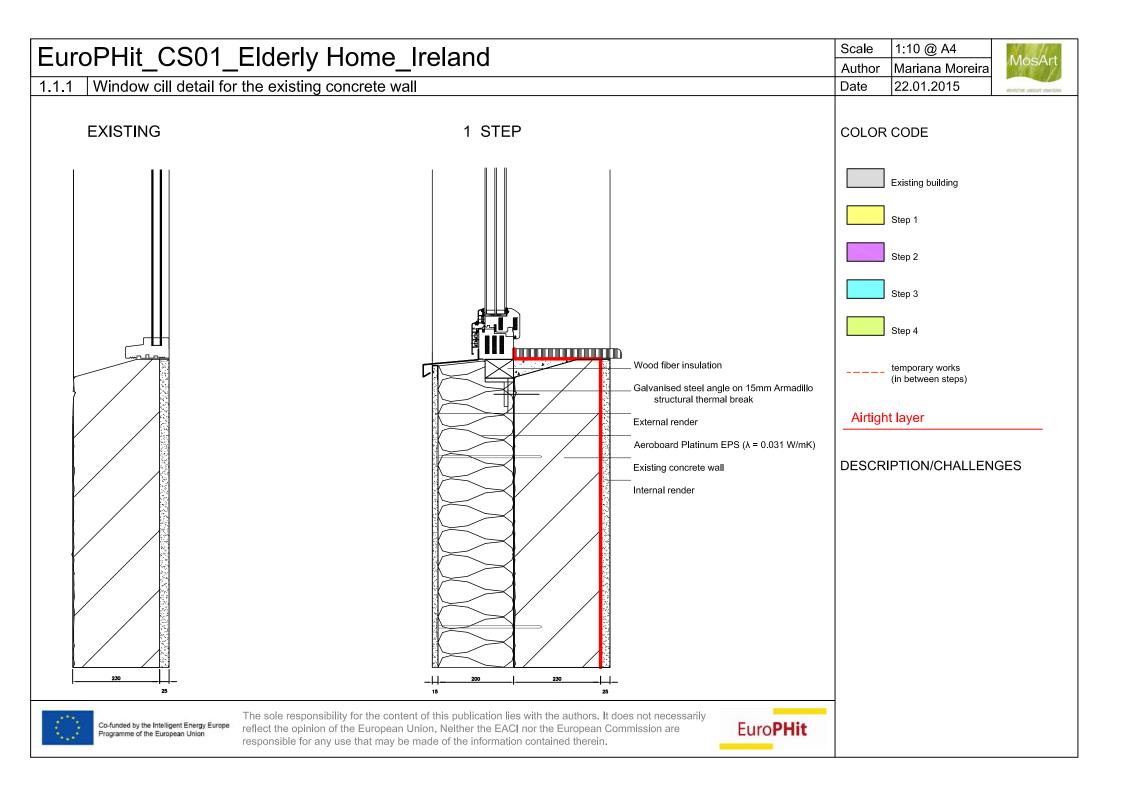
Ψ - value [W/mK] = 0.031

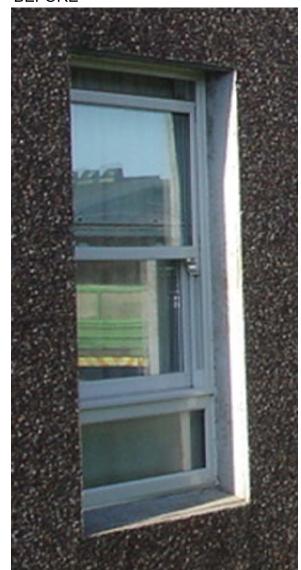
BEFORE AFTER
