Case Study_15_Tournon_France

Fssc Detail: Slab / Staircase to Basement

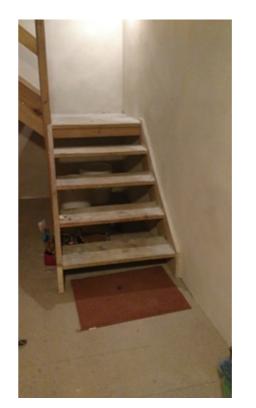
Plaster render on inner face of staircase walls for airtightness.
Last stair step cut to match new floor level

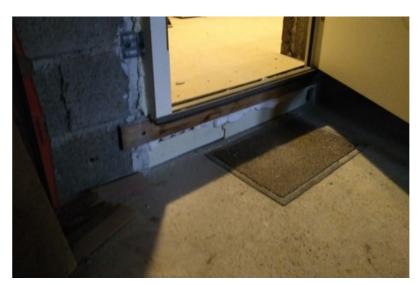
Passive House Door flushed on outer face. 180 mm PU floor insulation pushed until door sill to get continous thermal protection

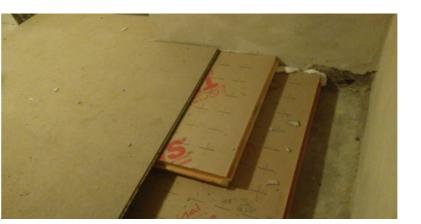
Staircase slab insulated by two layers of rigid tongue and groove PU panels (100+80 mm 0.022 W/m.K) + waterproof woodfiber panel 19 mm
