EuroPHit_OP21_MosArt_Family Home_Ireland

OVE01 Verge detail for timber frame with timber cladding - Site Photo

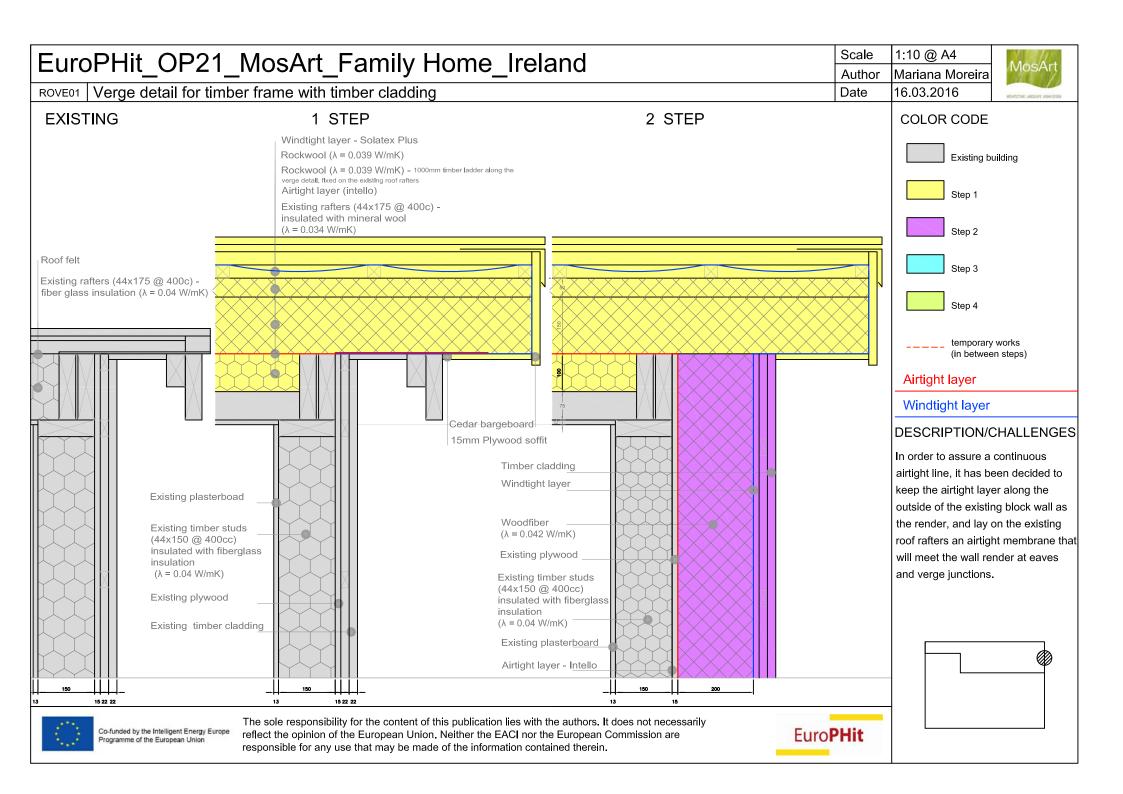
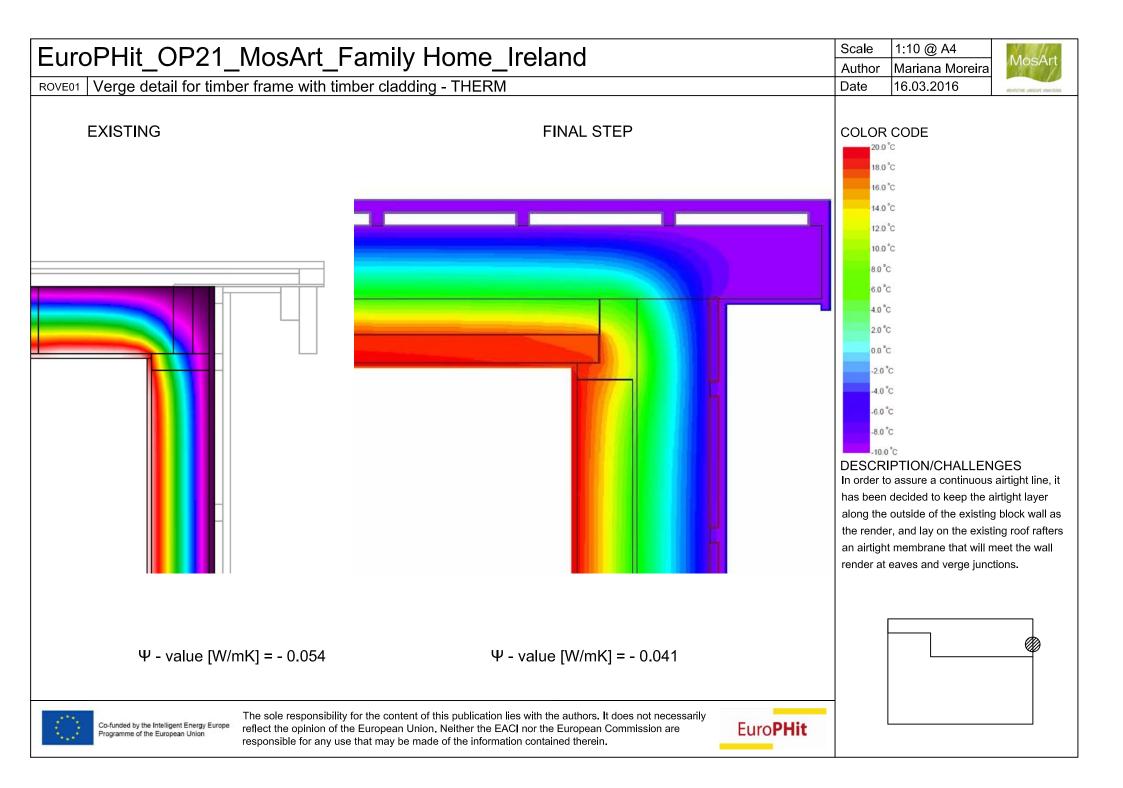
In order to assure a continuous airtight line, it has been decided to keep the airtight layer along the outside of the existing block wall as the render, and lay on the existing roof rafters an airtight membrane that will meet the wall render at eaves and verge junctions.
