CS14_Wilmcote House_United Kingdom

Author	Steven Stenlund	BRE
Date	March 2015

1.3.3 Garden side Eaves

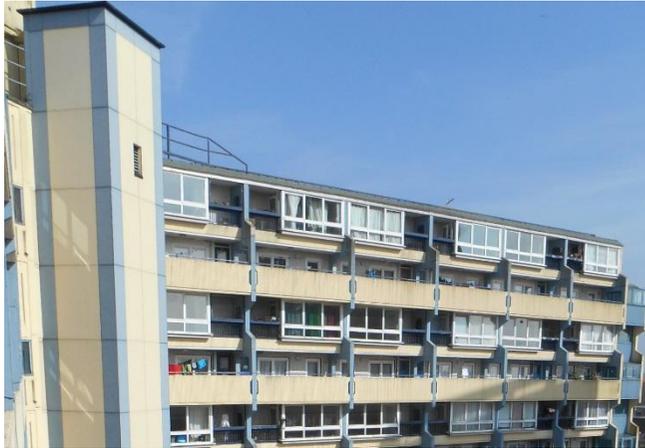
BEFORE

1.3.3 Garden side Eaves – site photo

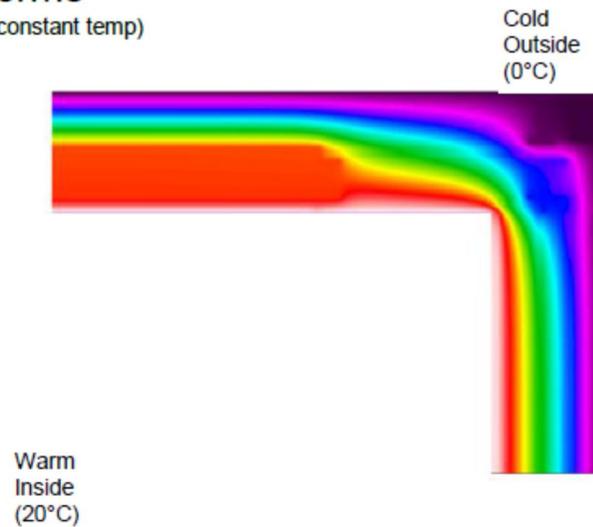
1.3.3 Garden side Eaves – Thermal model

FINAL STEP

Isotherms

(Lines of constant temp)

Ψ -value = -0.08 W/mK
