EuroPHit_OP21_MosArt_Family Home_Ireland

Window cill detail for timber frame wall

WIBO01 Window cill detail for timber frame wall - THERM

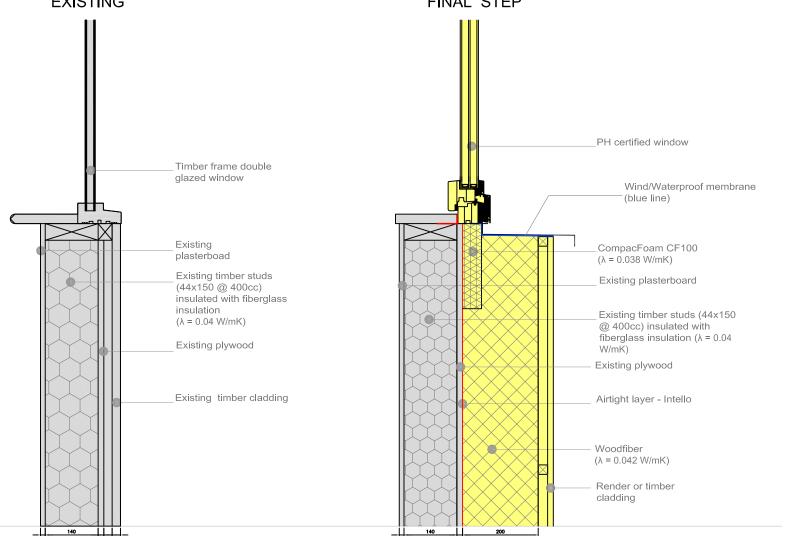
In order to assure a continuous airtight line, it has been decided to keep the airtight layer along the outside of the existing timber frame wall that will be further insulated with wood fiber boards in the second step of the Step by Step retrofit works. The airtight layer will be on the warm side of the wall build up.

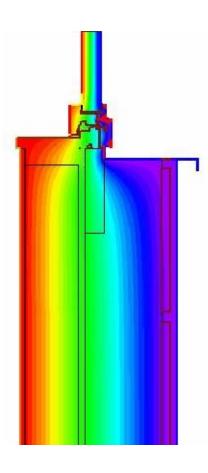
Ψ - value [W/mK] = 0.044

Ψ - value [W/mK] = 0.013

In order to assure a continuous airtight line, it has been decided to keep the airtight layer along the outside of the existing timber frame wall that will be further insulated with wood fiber boards in the second step of the Step by Step retrofit works. The airtight layer will be on the warm side of the wall build up.

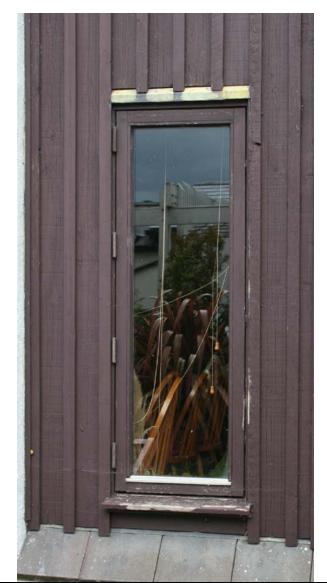
Window cill detail for timber frame wall - Site Photo

BEFORE

Retrofit works for this detail will be carried out as part of the final step of the Step by Step retrofit.

In order to assure a continuous airtight line, it has been decided to keep the airtight layer along the outside of the existing timber frame wall that will be further insulated with wood fiber boards in the second step of the Step by Step retrofit works. The airtight layer will be on the warm side of the wall build up.
